# SK<sup>®</sup> 4L30E

1991-2004 Isuzu, BMW, Cadillac

Reduces/Corrects/Prevents:

Chronic Low Band Failure, 2-3 Cut-loose,  
Direct Clutch failure.

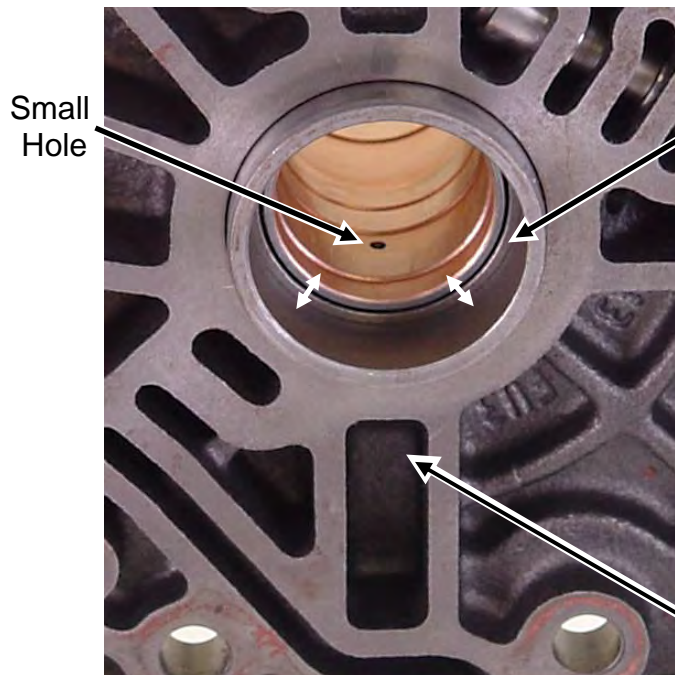
## Step1

**Support Bushing Installation:** Using new bushing driver provided, press old bushing out using care not to gouge the bore of the support where the bushing installs. Press New TransGo<sup>®</sup> Support Bushing into support. Small hole in bushing must line up with Small Hole Feed in support. Insert 3rd Drum Shaft into support. Must turn freely.

We recommend you use a press to install bushing. Make sure you guide bushing in straight or damage to bushing will occur.

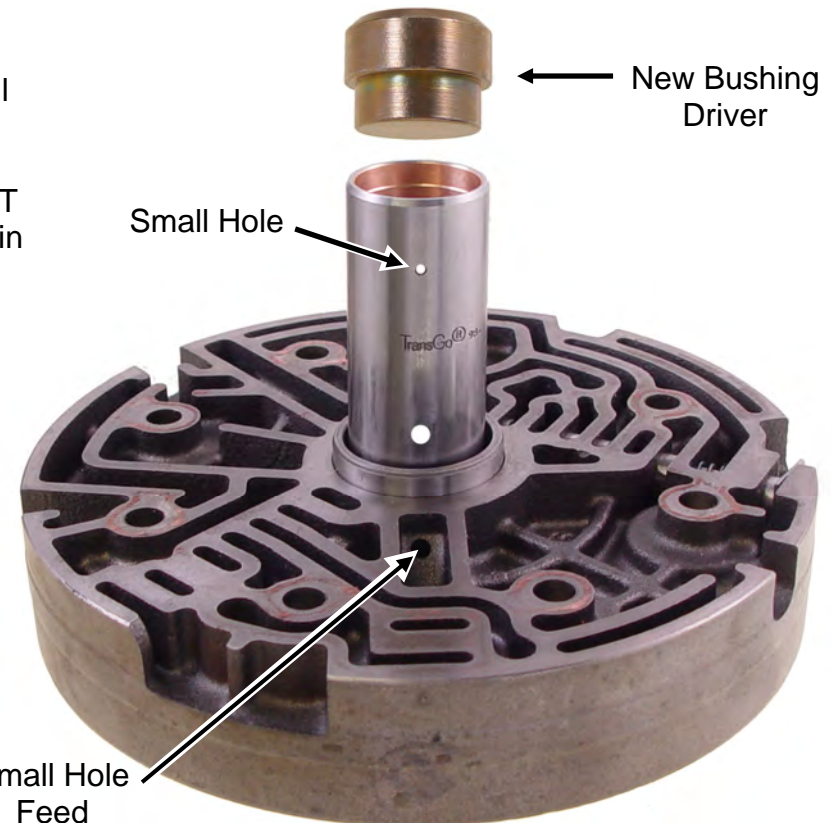
Press bushing in until flush with ledge. Blow air into Small Hole Feed. Air MUST come out small hole in bushing.

Shaft must turn freely in bushing—No drag.

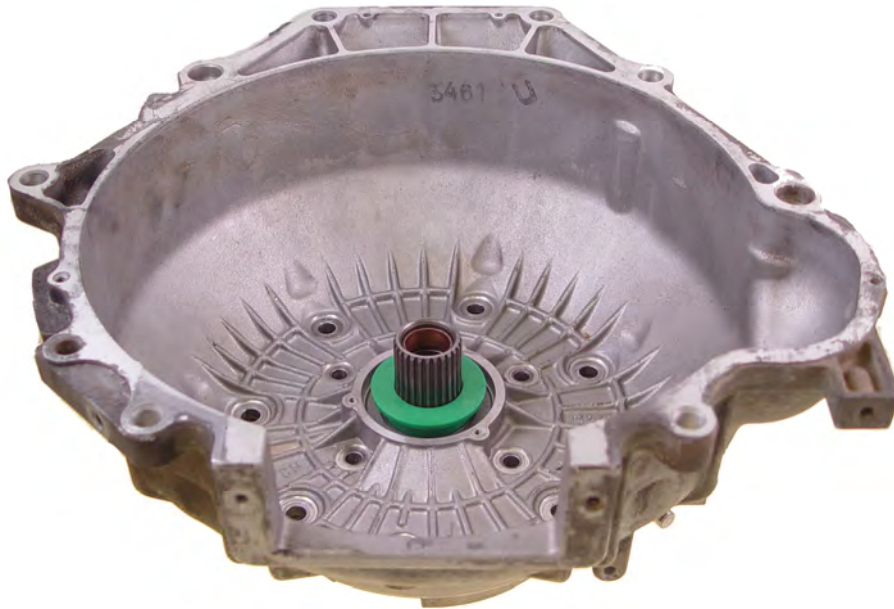
## Step 1 Pump Alignment Procedure:

Gently rocking bell housing on converter hub before assembly will flatten any high spots caused by driving or pressing in a new bushing. Now with a smooth converter bushing installed, lube and assemble pump parts. Install center pump bolts finger tight then back off a 1/2 turn leaving them loose. Insert **Tapered** Alignment tool until it binds between converter bushing and stator shaft. Do not drive it in! Re-align bolt holes if needed and tighten center pump bolts to 15 foot pounds. Remove alignment tool. Now install front seal.

Warm Alignment tool in hot tap water for 1 minute before using works best!

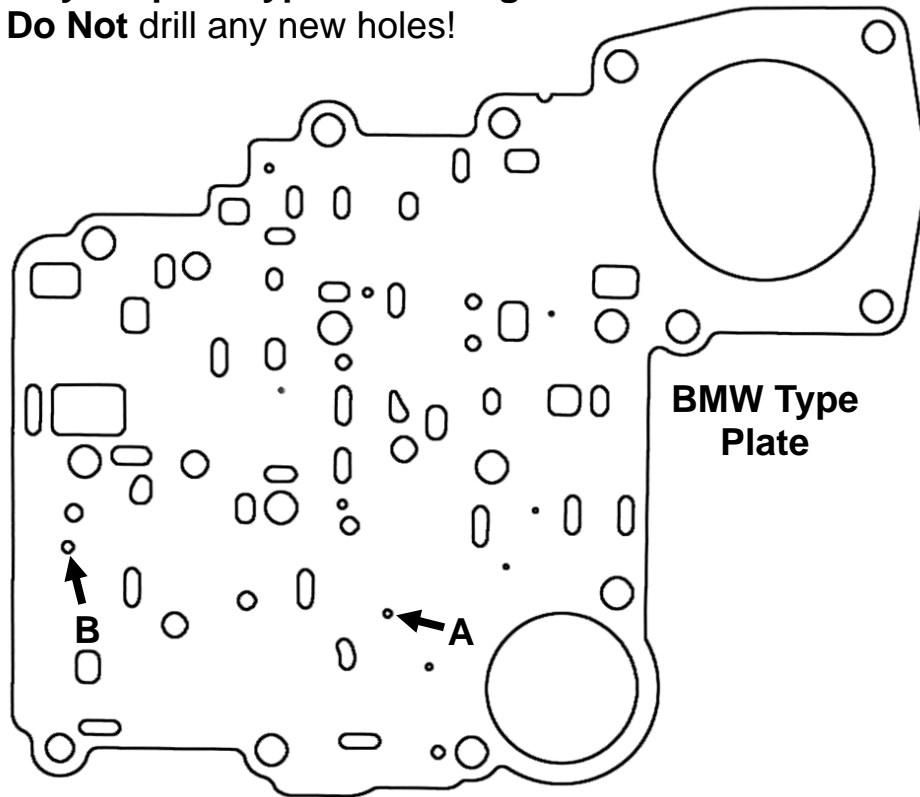
## Step 1

Locate holes A&B which match the locations for **your plate type** and **enlarge** them to .110  
**Do Not** drill any new holes!

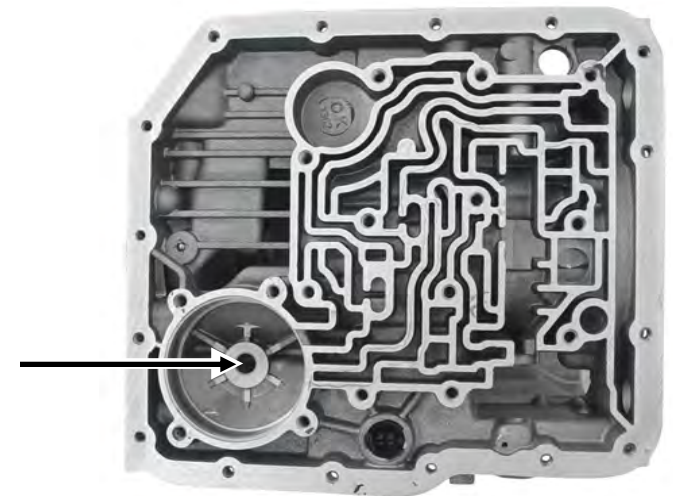
## Avoid a Headache!

Band apply pressure does NOT go away in 3rd and 4th. It is the RELEASE oil which pushes the band off on the 2-3 shift against servo apply. The release oil pressure is above the servo pushing it downward. If your servo pin bore is wore out, you have a leak in the release oil. Depending on the amount of wear it can slip 3rd and/or 4th as well as drag the 1-2 band and cause premature band failure.

Parts to fix this issue are available at [www.servobore.com](http://www.servobore.com)

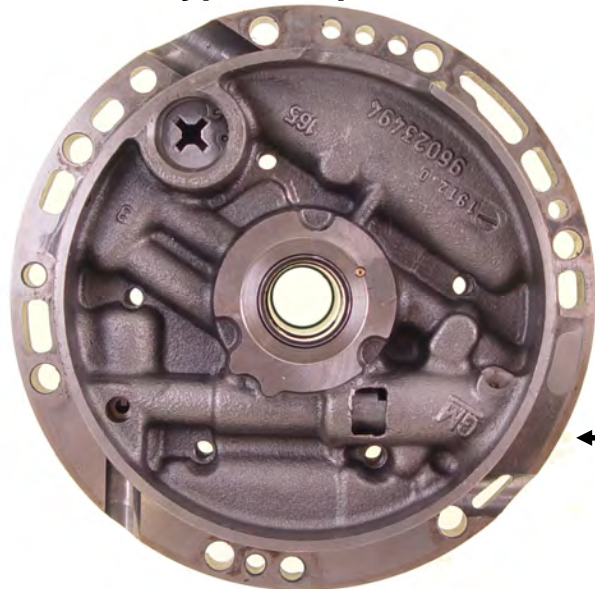
## PWM Type Pump Stator ID

**PWM** type pump & trans did **NOT** use orifice capsule in the nose of the input shaft and requires a **Woven Carbon** lining converter.

PWM has an open hole here. No Capsule!

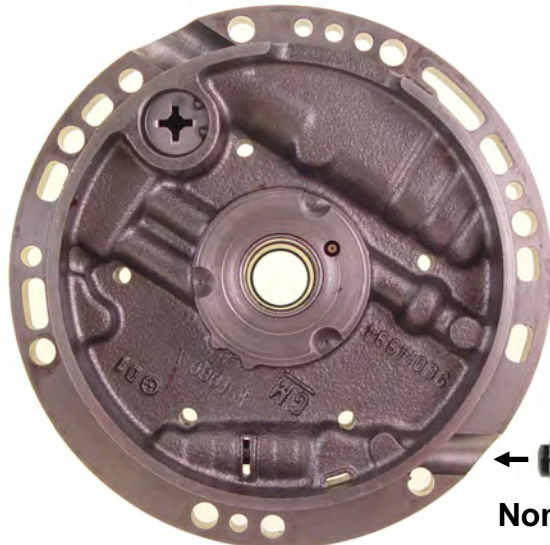
## Non-PWM Type Pump Stator ID

**Non PWM** type pump and trans should have an orifice capsule installed in the front of the input shaft and is used with a **Paper** lining converter.

Non-PWM has orifice Capsule here.
