SK® 44-55E Shift Kit®

Reduces/Corrects/Prevents

Forward Clutch Failure—2/3 Cutloose
Hard Throttle 2/3 Slip—4th and 2nd Band Failure
Coast 3/2 Clunk—Won't Move
Slipping Codes: 733—734—647—648

Fits: 1995-2010 4R44E, 4R55E, 5R55E

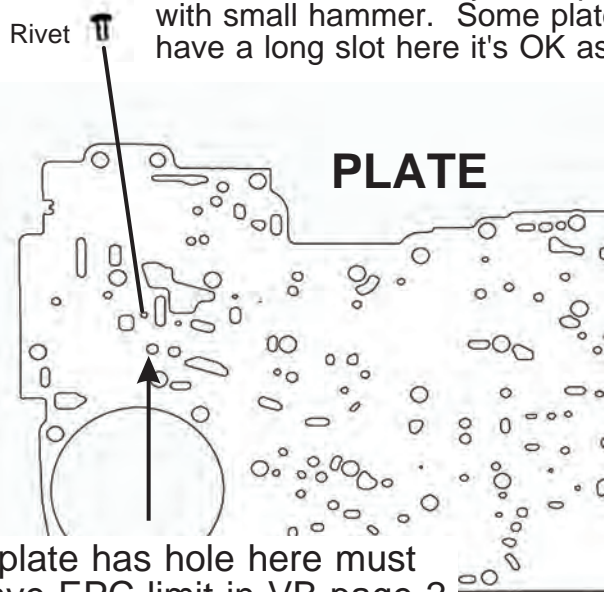
A. Insert small rivet furnished up thru this hole. Hit it smartly a couple times with small hammer. Some plates will have a long slot here it's OK as is.

It plate has hole here must have EPC limit in VB page 2

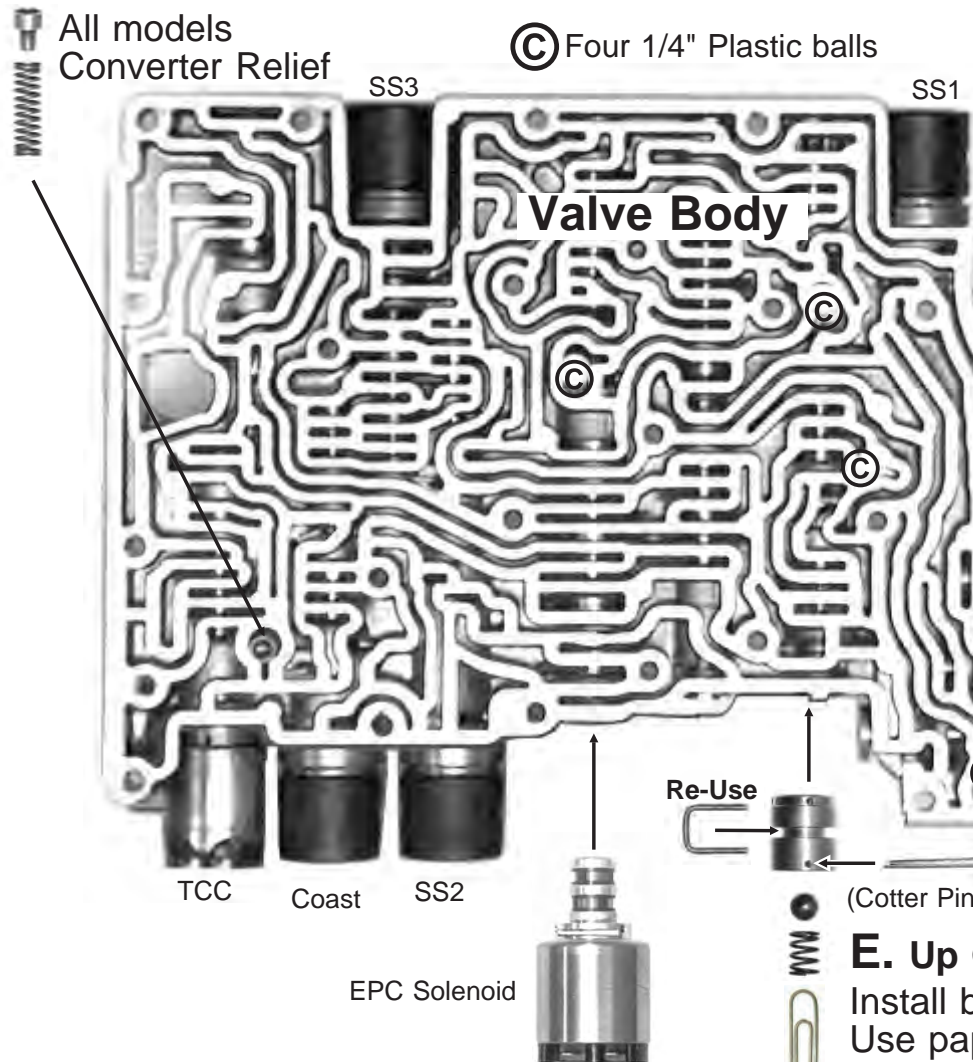
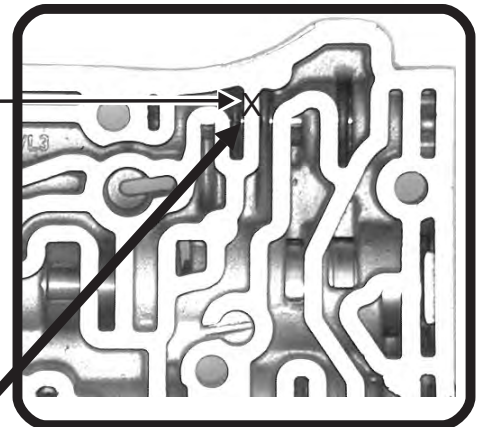
This EPC limit valve & spring was removed in later VB's. If plate has hole over this location EPC limit valve and spring must be installed.

A. YOU MUST cross drill thru partition, under the X, with the .063 (1/16") drill furnished.

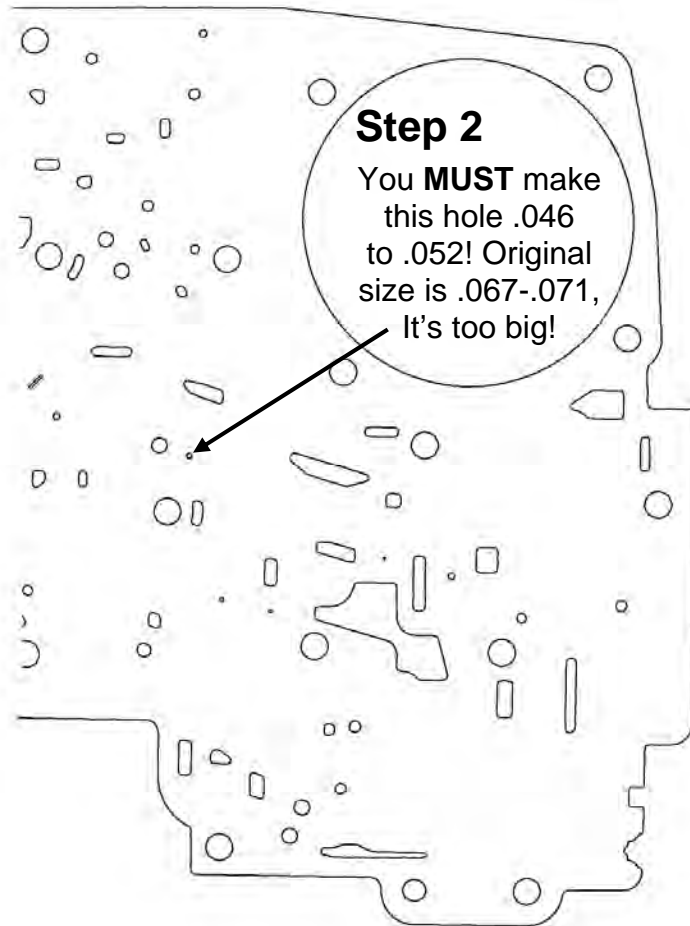
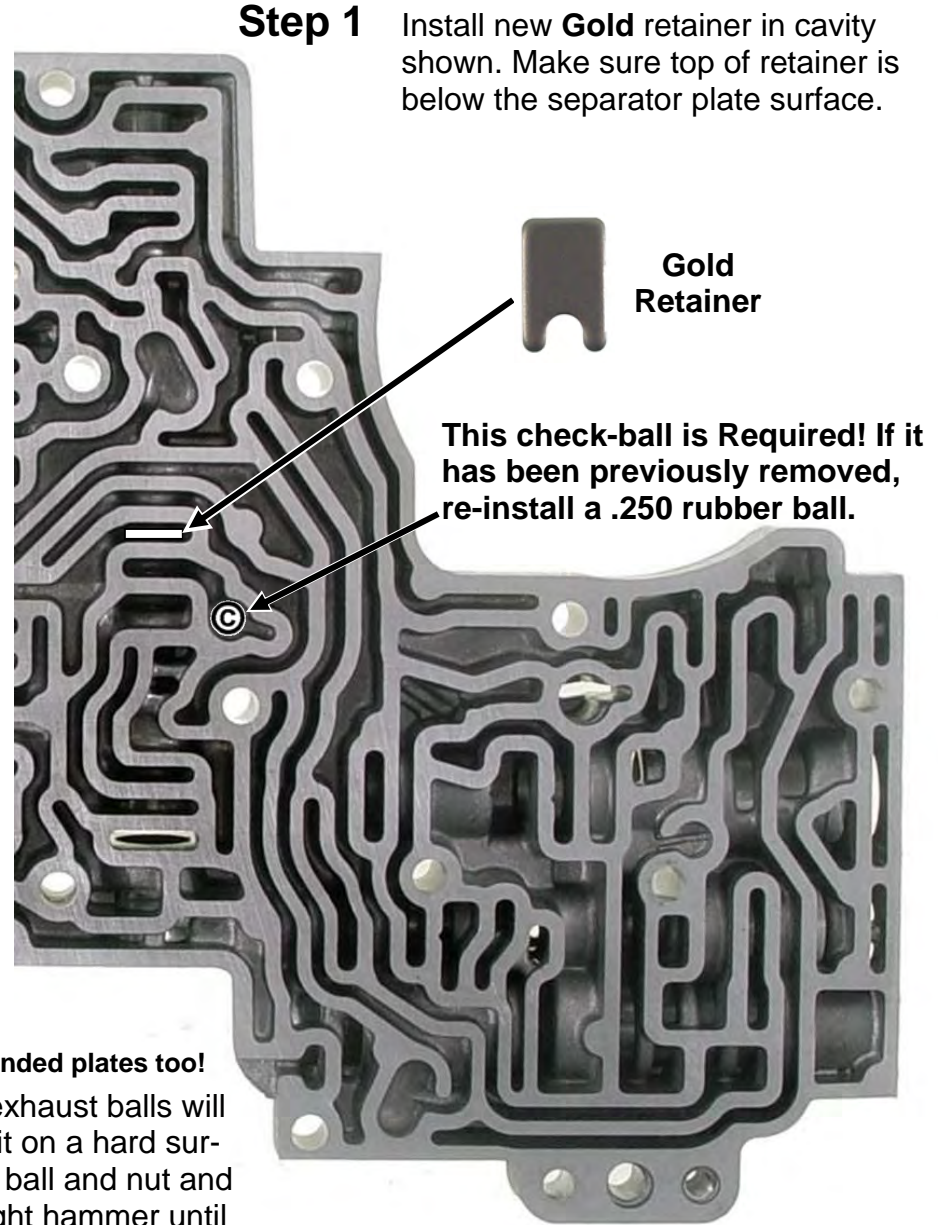
No Reverse or Delay Bang Reverse Correction.

Plate hole size reduction. Works on bonded plates too!

Use (2) approx .314 steel balls (700R4 TV exhaust balls will work) to downsize plates. Take 1/4" nut set it on a hard surface and set (1) .314 Ball on it. Lay plate on ball and nut and set other .314 ball on top. Hit top ball with light hammer until hole is .052 but no less than .046. Engagement into reverse will feel firm like A4LD. Smaller hole = less firm.

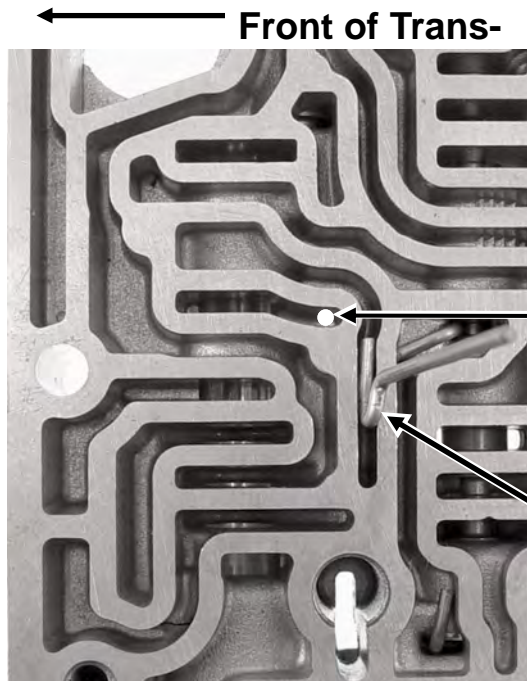
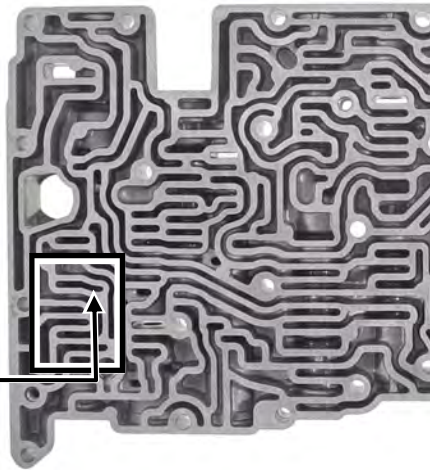
Step 1

After overhaul with a new converter some vehicles will still set TCC Slip or Stuck Off Codes when there is nothing wrong with solenoids, pump or converter. This Correction will usually take care of the problem **provided** there really is nothing wrong with the above items.

Remove TCC Solenoid, shift valve and spring. At the white dot shown below, drill a 1/16" exhaust hole down thru the floor and out the bottom of the VB. Clean drill chips and reassemble TCC Spring, shift valve and Solenoid. Hollow end of valve gets the spring, spring enters VB first!!

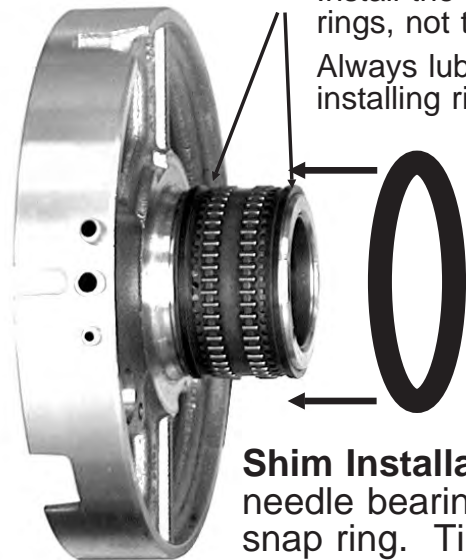
Center Support

End play is critical to prevent dumping at lube dam.

With needle bearing type:
 Install the SCARF CUT hard plastic rings, not the full circle rubber rings.
 Always lube rings & support before installing rings in groove.

This shim will fix it.

Shim Installation: Install shim then needle bearing. Install support and snap ring. Tip the trans up so the gear train weight pushes the support against the snap ring. Insert fingers thru the support and push on drum. If it moves a little it's OK. If its tight remove shim.
