TF-Boost

Fits: 46, 47 & 48RE's

An easy fix for VB's with worn Boost Bores. No special tools required. Corrects delayed or low line response especially in Reverse. This is the main fix for common reverse band burn up.

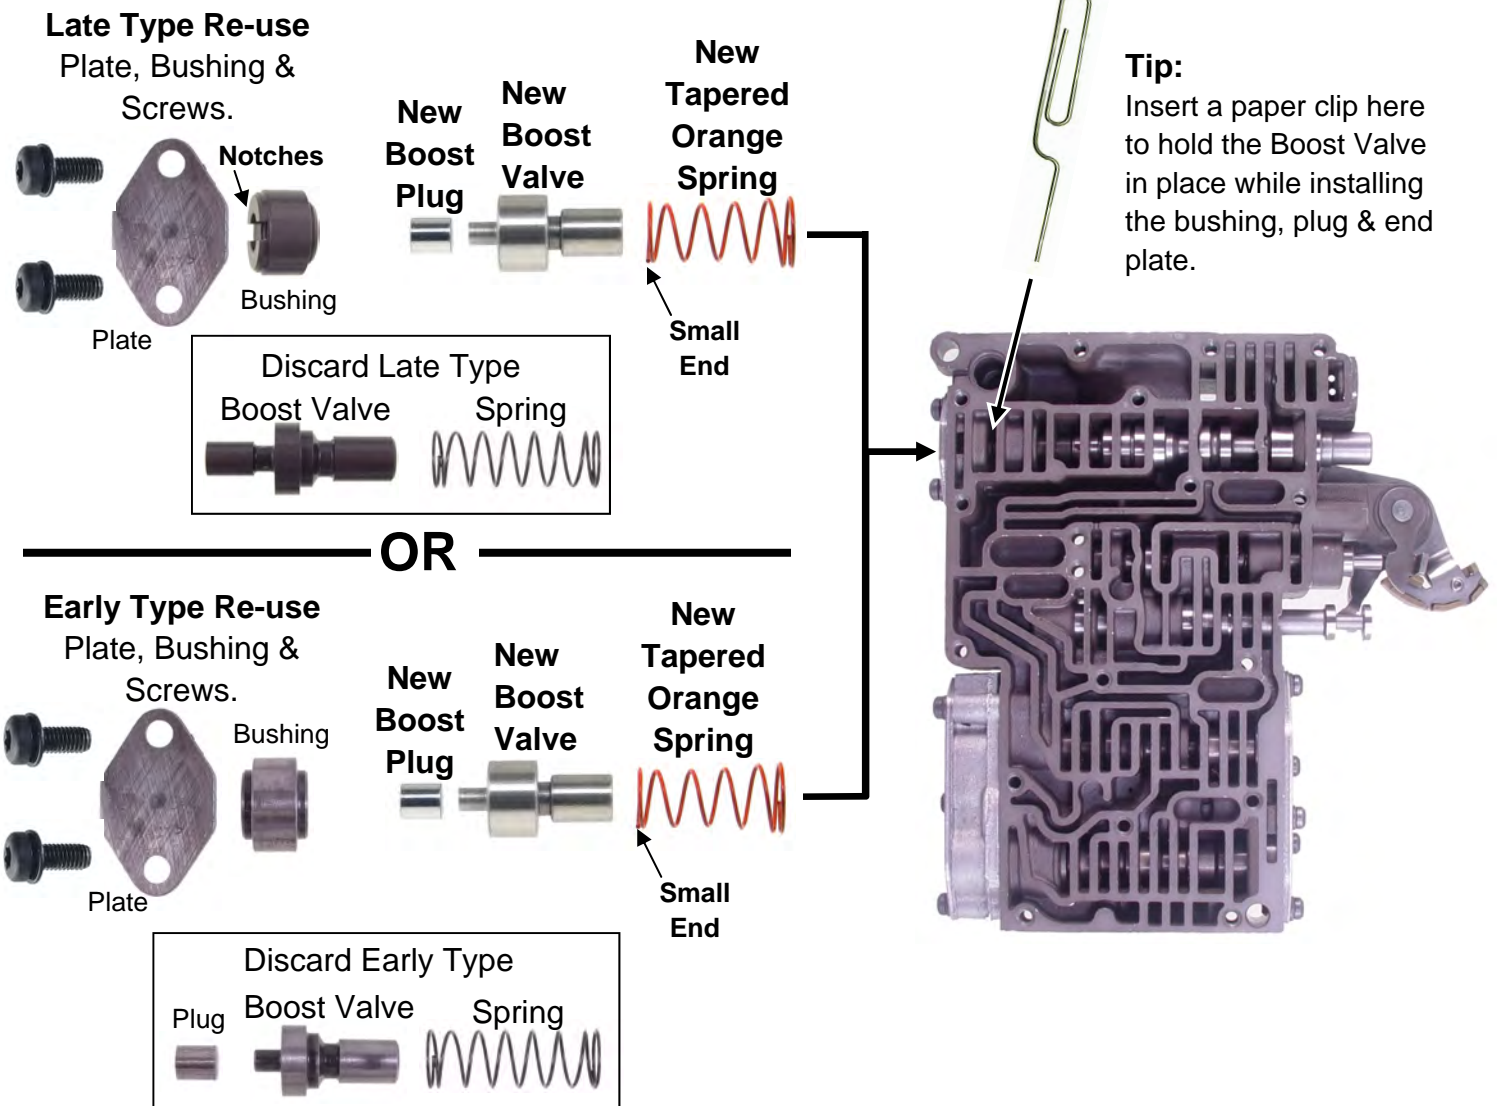
Install **SMALL** end of tapered **Orange** spring onto **New Boost Valve**. Use a paper clip to hold the boost valve in place after inserting it into the VB.

Insert **New Boost Plug** into original bushing & insert bushing into VB. If bushing has notches on one side, the notches on the bushing face the plate. Install plate and screws.

Remove and Discard original Plug, Boost Valve and Spring.
