# SK<sup>®</sup> 4L30E

1991-2004 Isuzu, BMW, Cadillac

Reduces/Corrects/Prevents:

Chronic Low Band Failure, 2-3 Cut-loose,  
Direct Clutch failure.

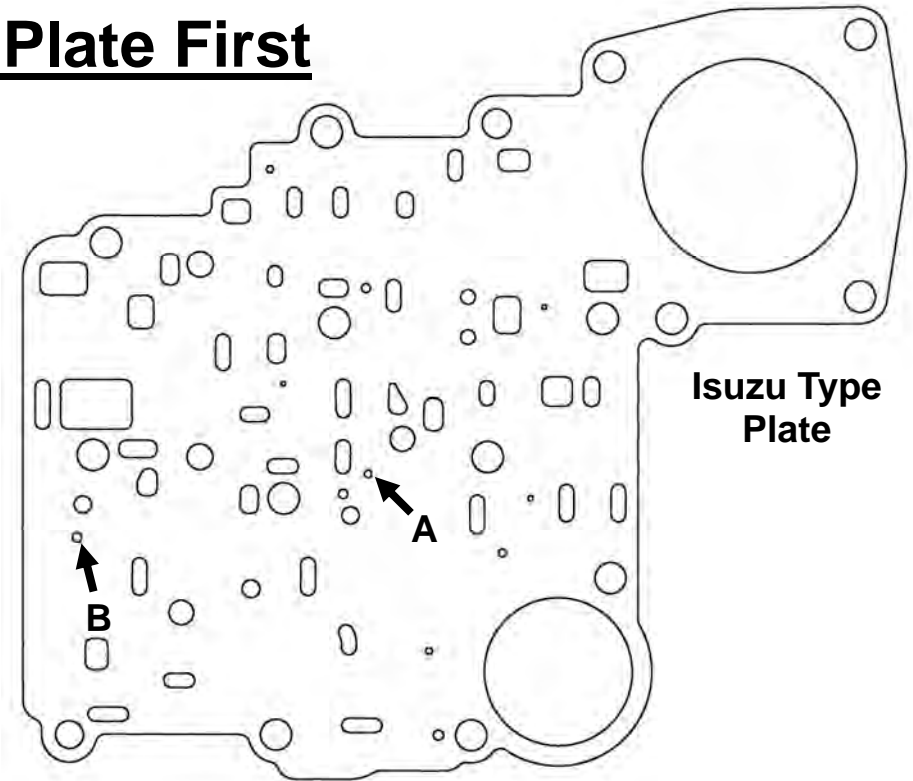
## ID Plate First

Band apply pressure does NOT go away in 3rd and 4th. It is the RELEASE oil which pushes the band off on the 2-3 shift against servo apply. The release oil pressure is above the servo pushing it downward. If your servo pin bore is wore out, you have a leak in the release oil. Depending on the amount of wear it can slip 3rd and/or 4th as well as drag the 1-2 band and cause premature band failure.

Parts to fix this issue are available at [www.servobore.com](http://www.servobore.com)
