# SHIFT KIT™ CAST IRON FORD 1973-77

SK3-73

*This FMX Kit fits '73 and later passenger cars with single and dual diaphragm modulators. It also fits '73 and later F-350-600 trucks with single diaphragm modulator and MX transmission.*

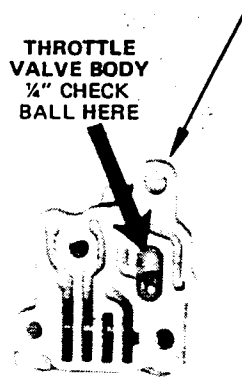
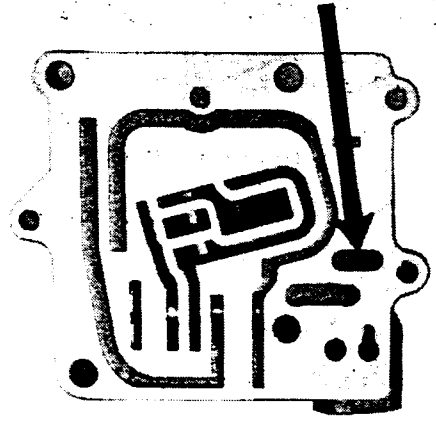
With this kit installed, valve body must contain two check balls:

Upper Valve Body - (See Figure 1.)  
Throttle Valve Body.

'73 & '74 MODELS  
DO NOT INSTALL  
CHECK BALL

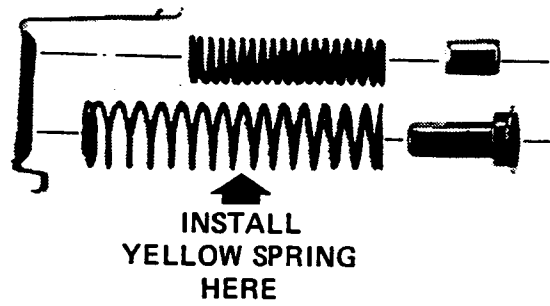
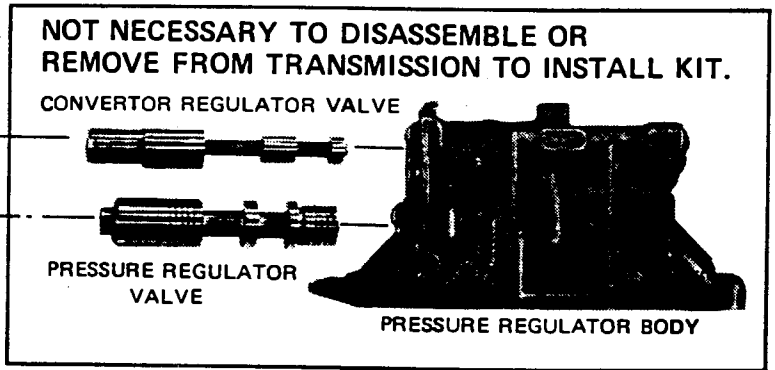
**4. FIGURE 4. - REGULATOR ASSEMBLY**

**ATTENTION:** LATE 74's HAVE A SINGLE SPRING TYPE REGULATOR ASSEMBLY. DO NOT INSTALL YELLOW SPRING. RE-USE ORIGINAL SPRING.

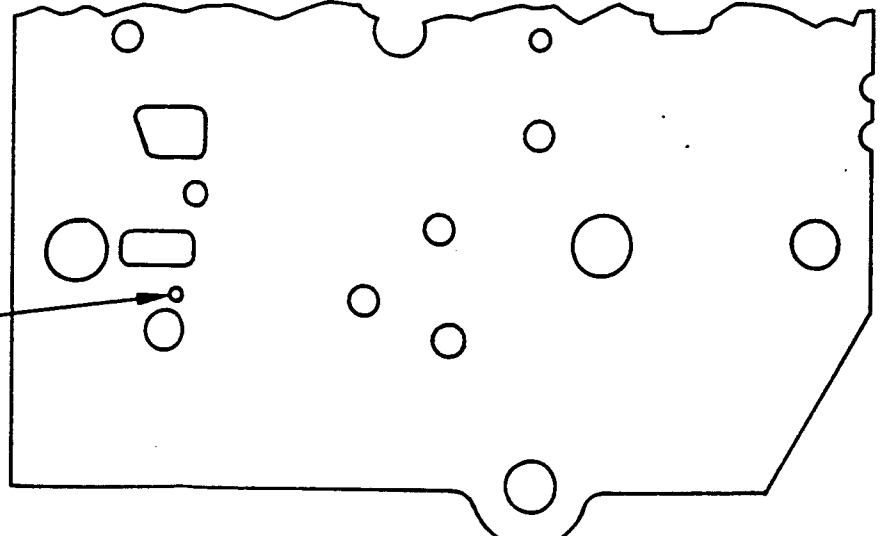
**5. FIGURE 5. - SEPARATOR PLATE**

ENLARGE THIS HOLE  
WITH DRILL (FURNISHED)

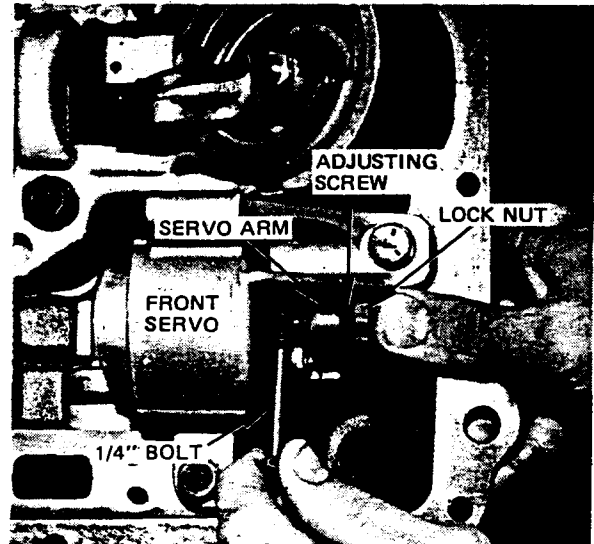
FIGURE 6.

1/4" bolt being inserted between Servo Rod and Band Adjusting Screw.

PULL BACK ON SERVO APPLY LEVER UNTIL ALL SLACK IS REMOVED FROM BAND APPLY LINKAGE.

Turn Adjusting Screw until 1/4" bolt will just pass between Servo Apply Rod and the end of Adjusting Screw with slight drag. (See figure 6) Then turn Adjusting Screw "IN" (Clockwise) one (1) Turn and tighten Lock Nut.  
(Use 1/4" bolt from valve body or any bolt that a 7/16" wrench will fit.)

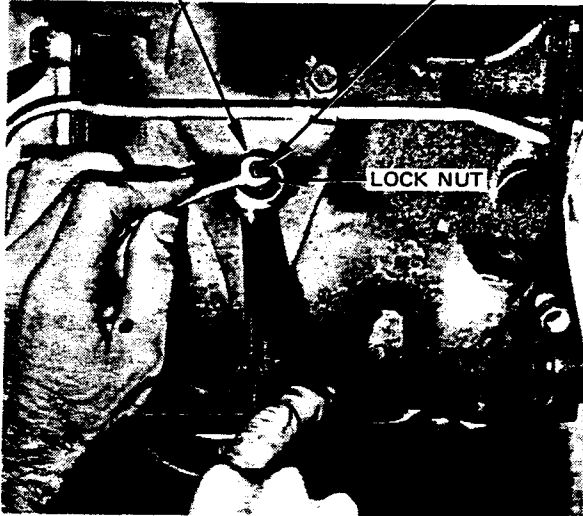
EXTERNAL ADJUSTMENT      ADJUSTING SCREW

FIGURE 7. — EXTERNAL ADJUSTMENT:  
Tighten to 10-12 inch pounds (tight with a short wrench) and back off 1-1/2 turns.

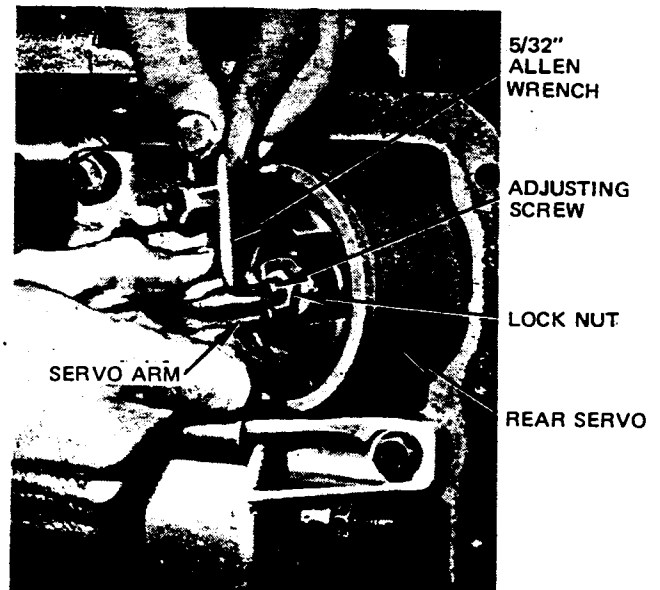
### FIGURE 7. — INTERNAL ADJUSTMENT ON SERVO APPLY ARM:

(Only used on some models.) Loosen Lock Nut, pull Servo Arm by hand, as shown in Figure 7. Turn Adjusting Screw until clearance has just been removed, then back off 7 turns and tighten Lock Nut.
