A4LD-A Junior - Shift Kit[®] SK[®] A4LD[™] System Upgrade

Reduces/Prevents/Corrects:

Direct clutch failure -- Delayed lockup release, chugs engine --
Soft 1-2 -- Cutloose 2-3 -- Delay or Bang reverse--Lockup too soft
Late shifts at light throttle -- No 4th -- 1-3 upshift at light throttle

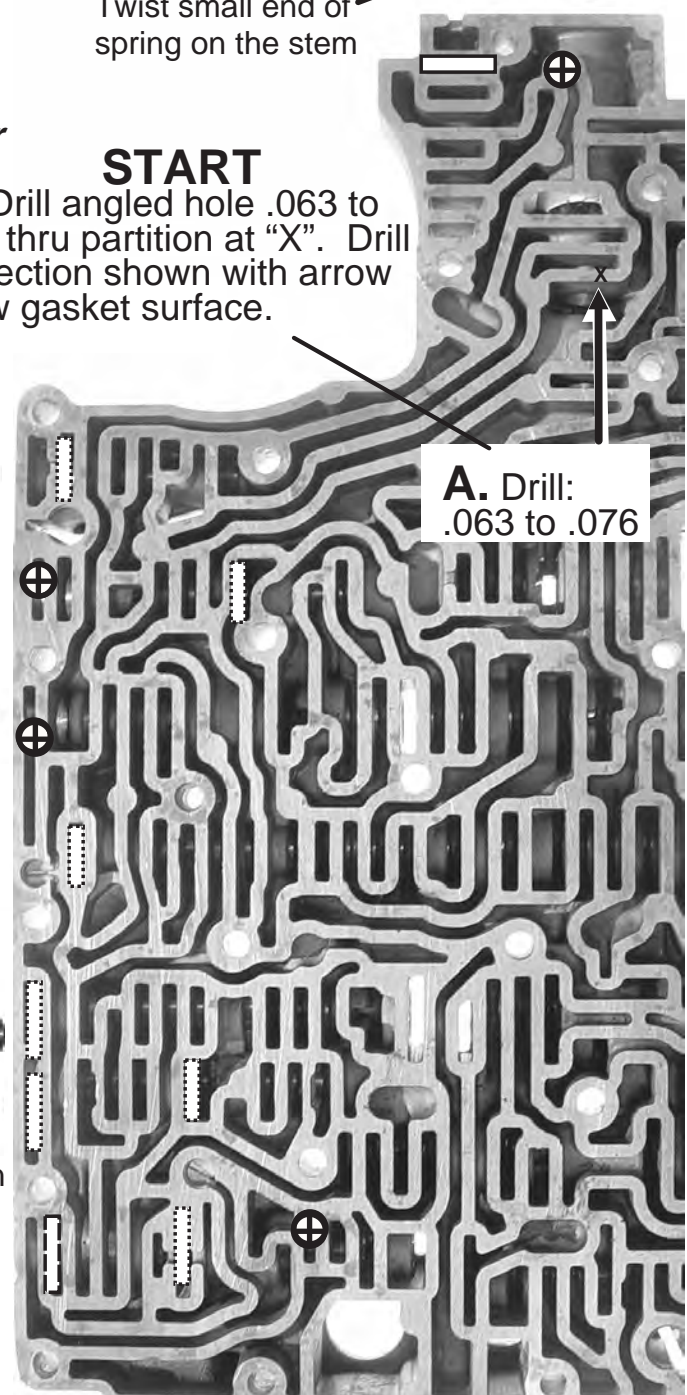
Valve Body Assembly

Drill at A, springs at BCDEFG, washer at H

Many valves are aluminum. They are very easy to scratch. Check all valves for sticking, but you may not want to remove a valve unless it is stuck or needs spring change. Some models don't have all the springs shown in picture. So don't be surprised if transition, orifice control, or throttle boost valve does not have a spring.

D. BLUE and White
Pressure regulator

Cutback Valve

C. Copper

B. White
Inner & outer

B. BLUE
Inner & outer

1-2 Transition

2-3backout

Orifice control

Throttle boost valve
Some had no spring

3-2 coast valve

3-2 KD timing

3-2 High clutch kickdown valve

3-2 Inner servo release kickdown

1-2 Accm valve

3-4 Accm valve

- A. Drill partition at "X" .063 to .076
- B. 2-3 BO 1st design-inner/outer BLUE
- B. 2-3 BO 2nd design-inner/outer WHITE
- C. Cutback COPPER
- D. PR inner WHITE
- D. PR outer BLUE
- E. Conv clutch shift valve ORANGE
- F. 4-3 torque demand (1-Sol VB) WHITE
- G. Conv shuttle valve GREEN
- H. Install washer on solenoid VB bolt.

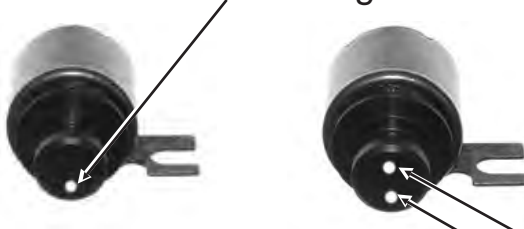
Solenoid 1st design: One hole

This kit corrects several causes of chugging, but will not correct chugging caused by worn out solenoid. How to fix it: If chugging occurs to low speed, disconnect wires to trans. If chugging still occurs replace solenoid with a NEW 2nd design solenoid E5TZ-7F037-A. Installing another used 1st design solenoid may not fix it.

Solenoid 2nd design: Two holes

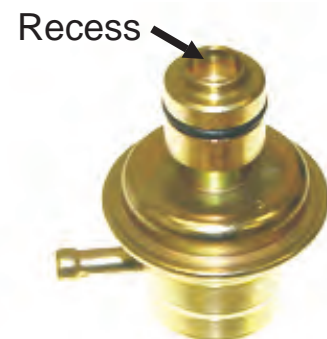
Modulator identification

A4LD Recess: 1/4" deep
 C3 Recess: is 1/8" deep

#E5TZ-7A377-C
